BioMax Environmental Environmental Consulting and Industrial Hygiene Services

Mitigation Procedures for Moisture Impacted – Break Room 1905 Area Department of General Services Board of Equalization Building 450 N. Street Sacramento, California

Attachment A: Digital Images
June 11th, 2008

BOE Building 19th Floor Break Room Areas (1905 + 1908)

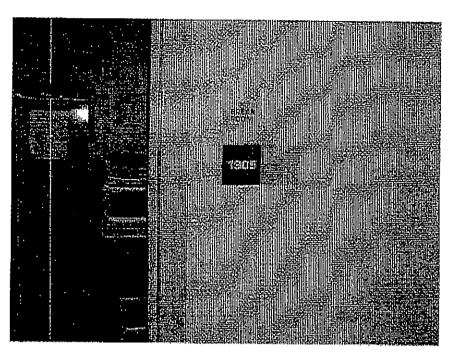
Image of 19th Floor Break Room (1905) main entrance at time of assessment of BOE Building (Subject Building) located at 450 N Street, Sacramento, California.

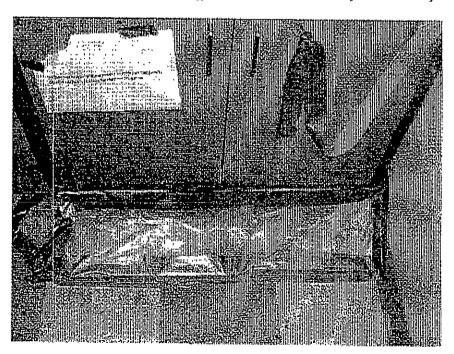
- At the time of our preliminary inspection performed on Wednesday, June 11th, 2008, BioMax observed the 1905 break room at approximately 12:00 pm during normal BOE staff use and occupancy. Upon entry into the 1905 break room, BioMax noted the presence of an interim plastic barrier reportedly installed previously by BPM personnel. Such barrier consisted in a plastic sheet extending from the cabinet door base to the tile flooring and duct tape covering the cabinet joints. Signage was also placed on the door as an intended instruction to preclude access into the interior cabinet.

2) Image of sink cabinet at time of assessment. Noted signage and interim plastic and duct tape barriers were present as noted as installed (according to DGS) by BPM site representatives.

1) The water and mold impacted sink cabinet within 1905 should be immediately isolated with plastic containment barriers so as to preclude access and direct physical contact with (and/or disturbance of...) the mold damaged materials. This action has been completed by JLS as of

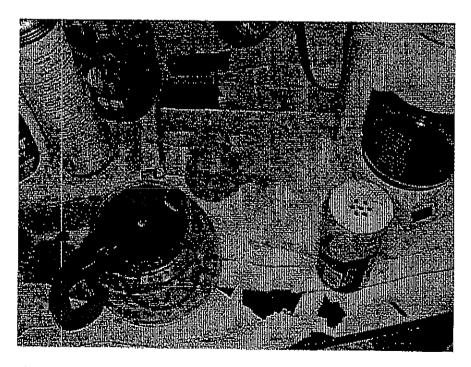
- Careful removal of the barrier and inspection of the cabinet sub-sink cavity revealed visual observations of significant historical moisture damage as indicated by laminant cracking, discoloration, and decomposition within the cabinet base materials. Significant mold-like odors were also noted emanating from the opened sink cabinet cavity at the time of our inspection. Hence, digital images were promptly collected and the cabinet doors were immediately closed as a precautionary measure as mold damages were verified subjectively and no additional sampling data (other than those collected previously by HTI) were deemed necessary.

4) Close-up image of stained and cracked cabinet materials associated with chronic historic moisture release within sink area plumbing systems.

- 7. BioMax specifically recommends that all affected floor mounted sink cabinet materials within each noted areas where visual evidence of potential moisture intrusion and damages has been identified, be removed for inspection of the interior and adjacent wall cavities/underlayment. As verified through inspection, any affected interior sheetrock and building materials shall be digitally documented and removed, wherever feasible, to the extent of visible staining, at a minimum. Flooring materials present within the impacted areas shall also be removed under containment controls for appropriate inspection of subflooring underlayment. Removal of moisture impacted and mold damaged materials may employ the use of appropriate item-specific containment methods and systems (such as sealed plastic glove-bag containment systems, or equivalent) applicable to the materials being removed at the discretion of the mitigation contractor. BioMax currently anticipates that all visually affected sheetrock, floor mounted cabinets and floor covering materials present within the break room areas shall be removed for disposal, and physical inspection of wall cavities and underlayment, as necessary. Any underlayment materials exhibiting visible signs of moisture staining shall also be removed or decontaminated (as noted below), as necessary.

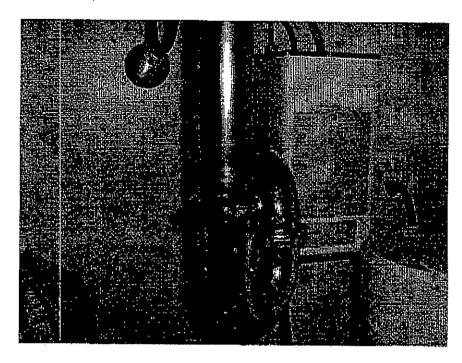
5) Image of sink cabinet "S" effluent trap and InstaHot water heater unit on rear wall. Note staining trail from InstaHot unit visible in image at time of assessment.

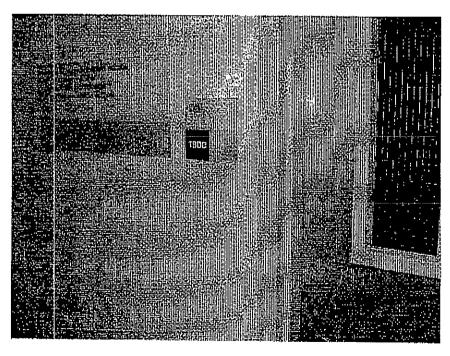
6) Image of entry to room 1908 which shares an interior wall and is adjacent to break room 1905.
